Butler - Auburn Redevelopment Plan Update

Part III : Existing Conditions

Part 3 Issues And Opportunities

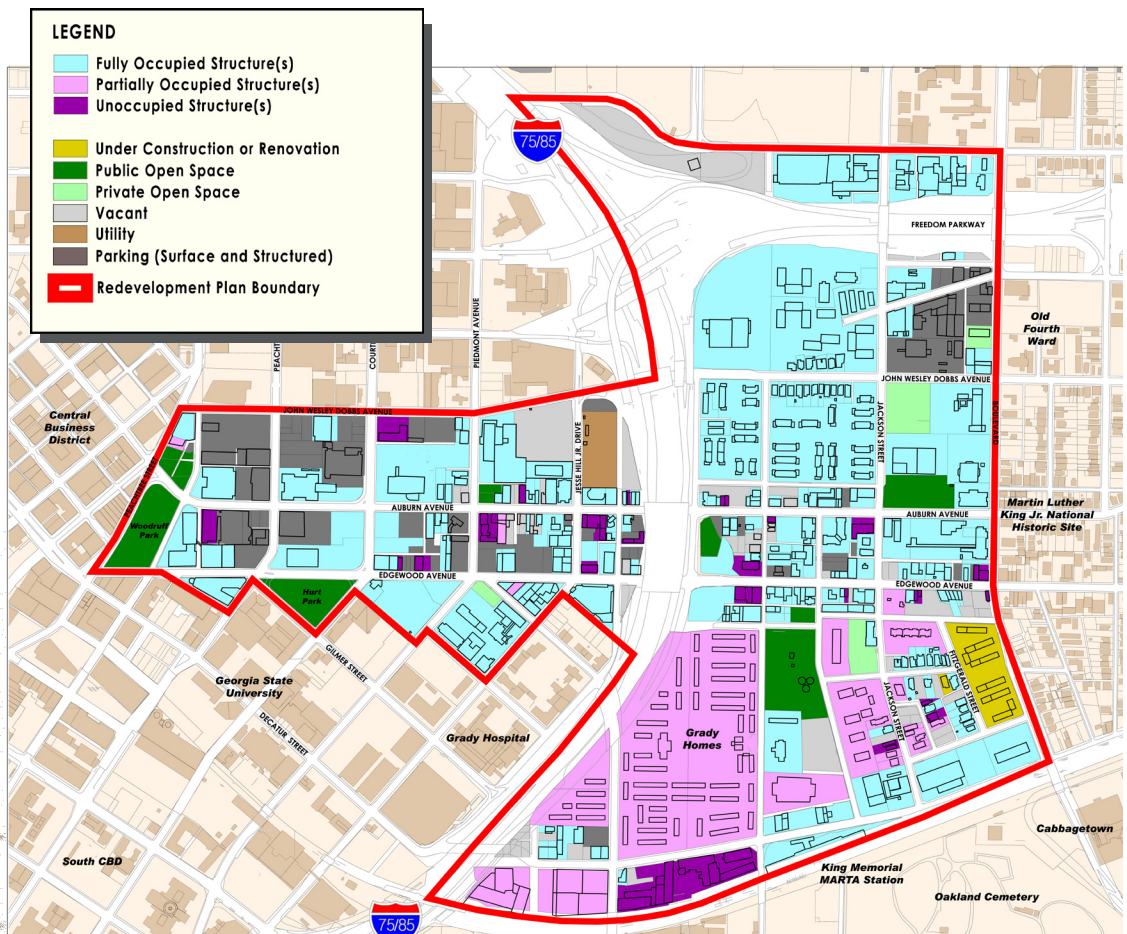
Figure 3.4:
Existing Building
Occupancy

Along with the survey of building condition, each property was checked for signs of habitation. The following designations were used to evaluate building occupancy:

While almost 76% of the parcels in the study area were observed to contain 'occupied' buildings, over 24% of the parcels appear to have unoccupied or only partially occupied structures. This is a relatively high number given the area's prime location within Downtown Atlanta and creates an overall sense of neglect and disinvestment. On the other hand, this also represents some opportunities to target redevelopment efforts.
